# Final Inspection Resolution Report

Single-family home, Denver, Colorado

| Contractor | Brimie Contractors LLC |

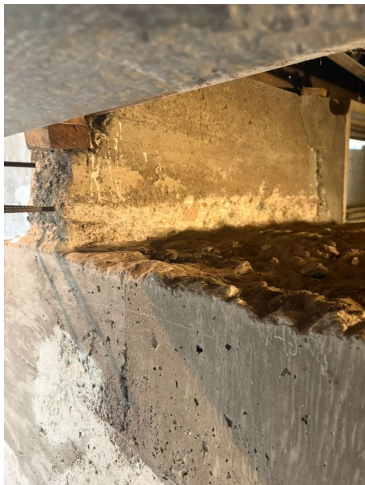
| Inspection concern | Deteriorated, spalled concrete at the beam bearing pocket on the basement wall. |

BEFORE - spalled beam pocket

| Work performed | Repaired to a licensed structural engineer's written recommendations: temporary shoring; removal of spalled concrete; rebuild with 8,000 psi structural concrete and epoxy-set dowels; moisture barrier; pressure-treated ledger on adhesive-set threaded rods; new pressure-treated post; side member and joist blocking / kicker bracing. Completion photos were reviewed and the finished repair approved by the engineer of record. |

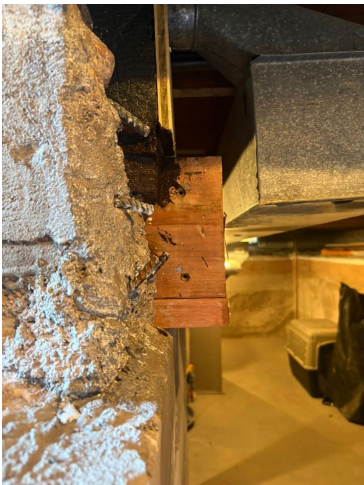
DURING - shoring and new ledger

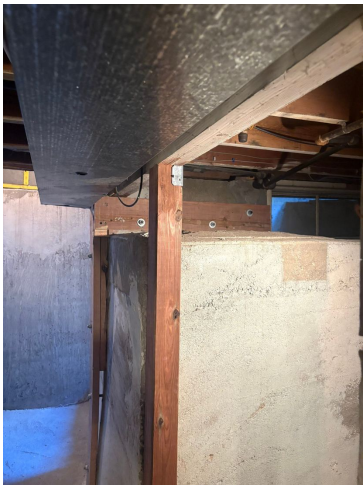
AFTER - new post and ledger

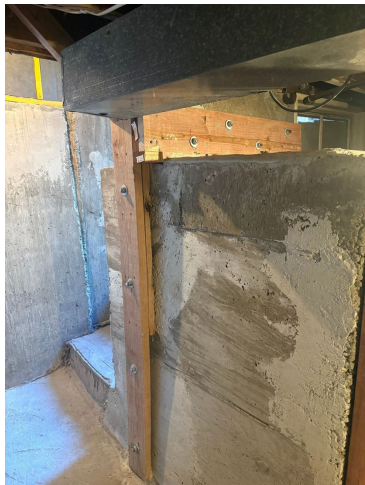
AFTER - rebuilt pocket and ledger

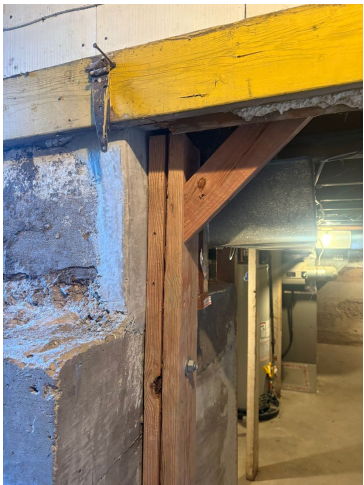
AFTER - completed repair, wall view

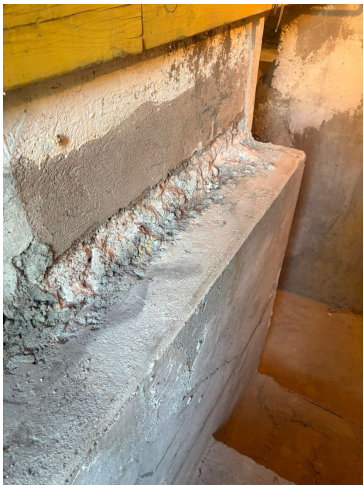
AFTER - rebuilt concrete at pocket

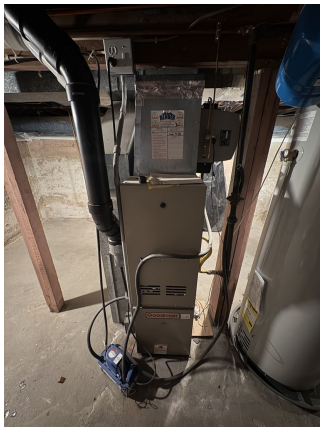
| Inspection concern | Existing furnace recommended for replacement. |

BEFORE - original furnace

| Work performed | Removed and disposed of the existing furnace. Installed a new 95%+ AFUE condensing gas furnace with PVC intake and exhaust, gas and electrical connections and condensate pump. Started up and tested. Permitted; final inspection passed. |

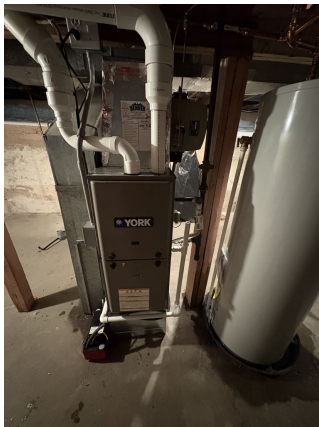
AFTER - new furnace and venting

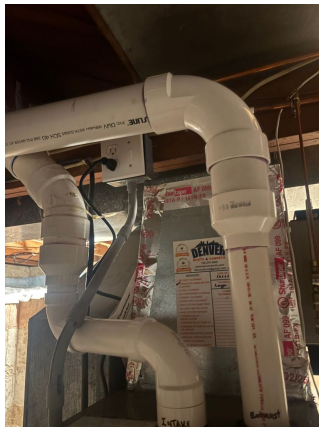
AFTER - new PVC intake and exhaust

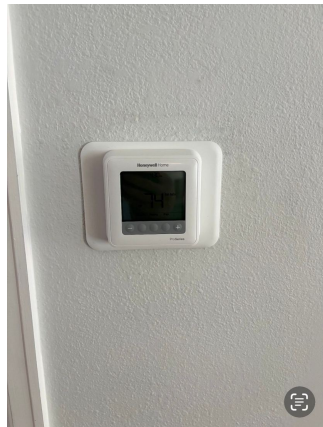
AFTER - new programmable thermostat

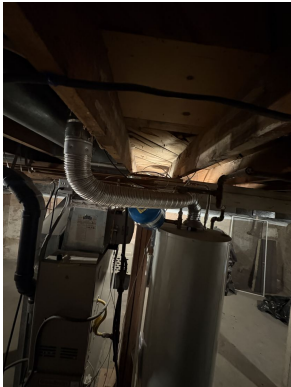
| Inspection concern | Flue connector lacked proper upward slope. |

BEFORE - flexible flue connector

| Work performed | Reworked the Type B flue connector with continuous upward slope of at least 1/4 in. per foot. |

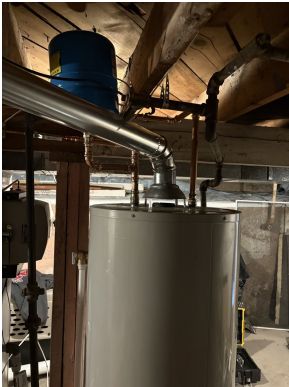
| Inspection concern | Expansion tank supported only by the piping. |

AFTER - rigid flue, supported tank

| Work performed | Installed a wall bracket and strap; verified tank air charge. |

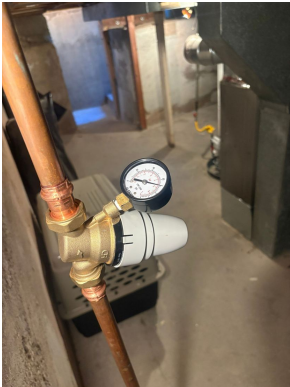
| Inspection concern | Incoming pressure measured at approx. 120 psi. |

AFTER - new pressure reducing valve

| Work performed | Installed a pressure reducing valve with gauge and adjusted to 60-70 psi. |

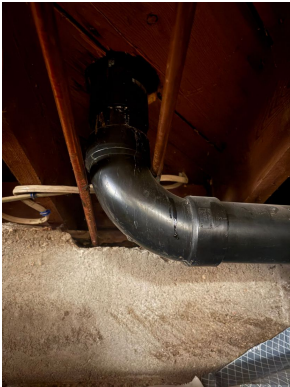
| Inspection concern | Active leak at the bathroom toilet drain, visible from the basement. |

AFTER - new drain fitting

| Work performed | Replaced the leaking drain fitting and closet flange; reset the toilet and water tested. |

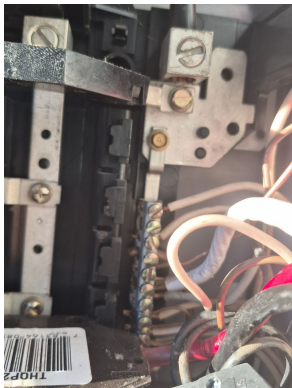
| Inspection concern | Double-tapped neutral and ground conductors. |

AFTER - one conductor per terminal

| Work performed | Separated neutrals and grounds to individual terminals. |

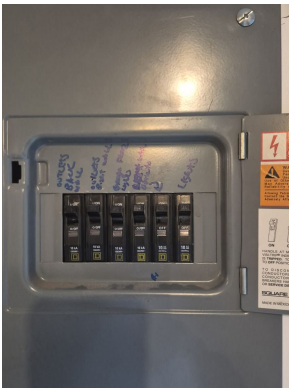
| Inspection concern | Breakers not labeled. |

AFTER - sub-panel labeled

| Work performed | Traced, tested and labeled all breakers in the main panel and garage sub-panel. |

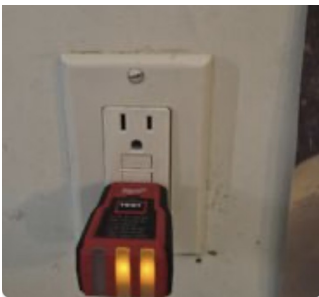
AFTER - GFCI tested

| Work performed | Installed GFCI/dual-function breakers protecting the countertop receptacles; tested. |

| Work performed | Replaced with a weather/tamper-resistant GFCI and verified downstream protection. |

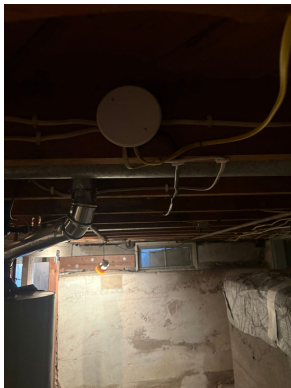
| Inspection concern | Open junction boxes, exposed wiring and a detached fixture. |

AFTER - basement wiring secured

| Work performed | Made safe, installed box covers, secured wiring and reinstalled the fixture. |
